The Perfect (Retro)Fit: Overcoming Challenges with Curtain Wall Retrofits

By Rob Wood, PEng., President, C3 Polymeric

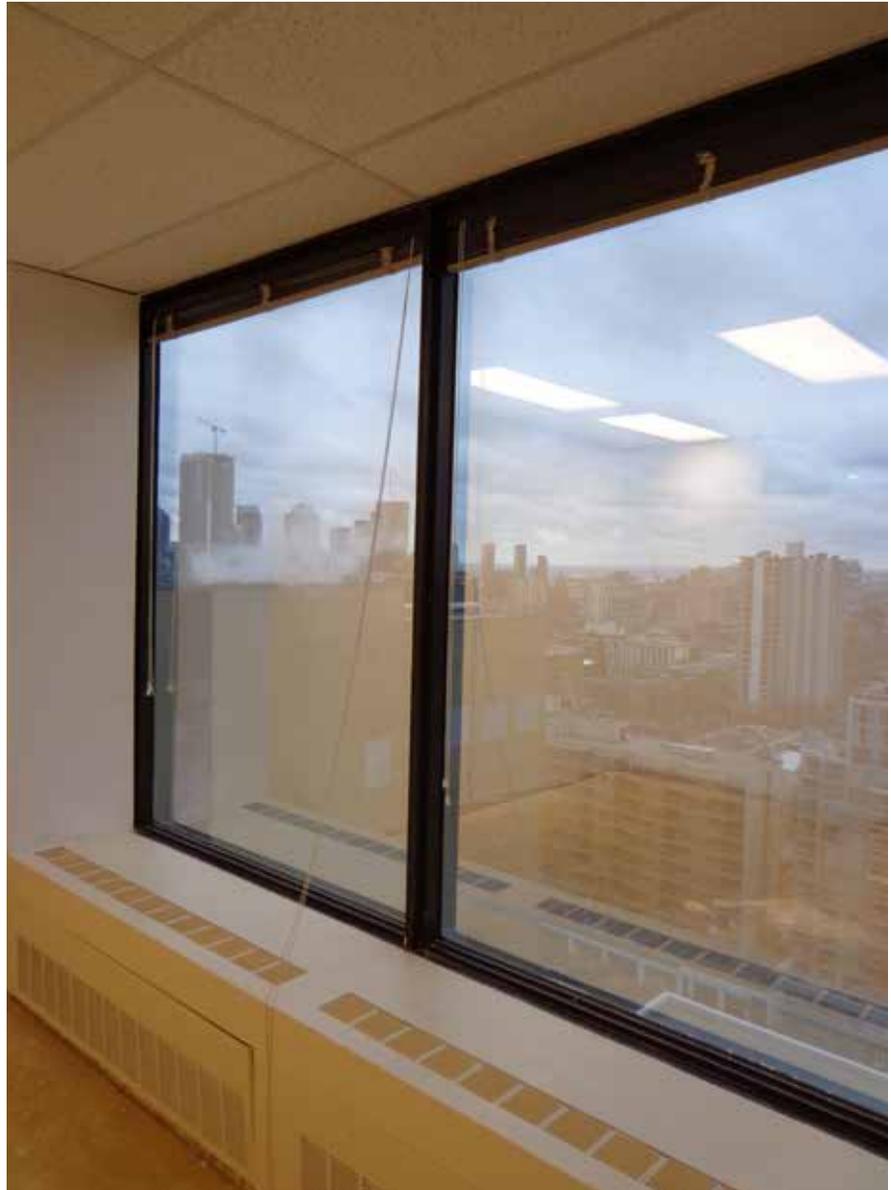
A view before the retrofit.

Having managed 400 University since 2004, Crown understood the limitations of its original façade. The façade used single glazing throughout the tower, including the ground floor. Poor detailing in the spandrel areas and the second floor soffits resulted in significant air and water penetration. While attempts had been made to repair the building, their success was limited by inherent design flaws in the façade.

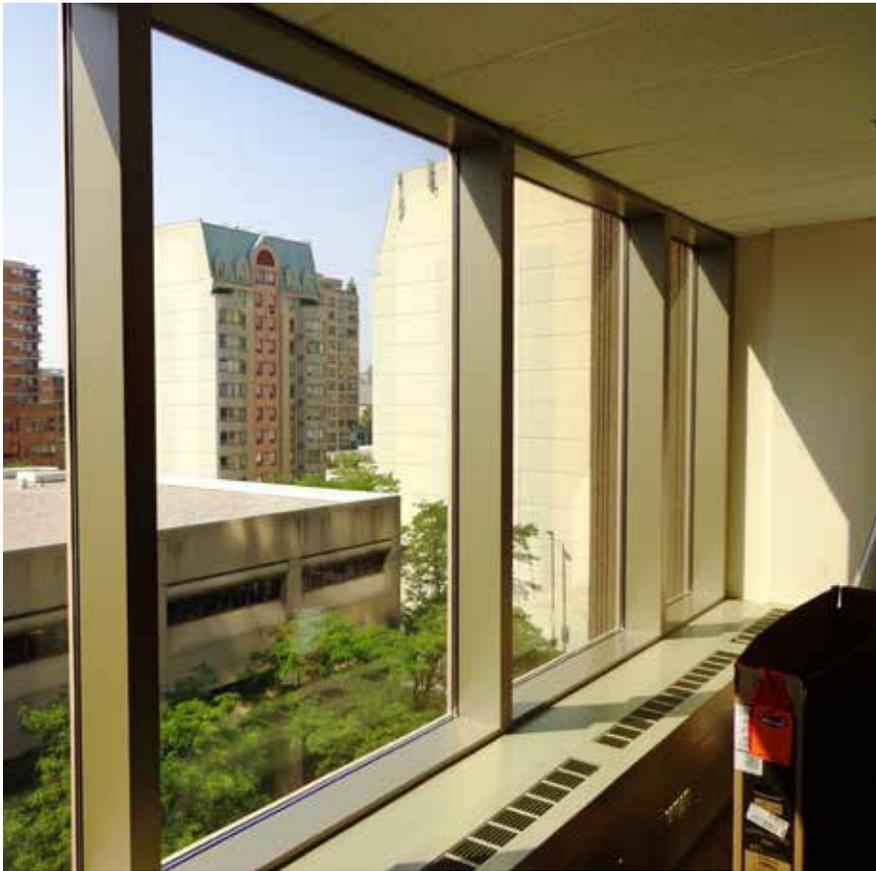
A view after the retrofit.

Because the system was fully custom, the team at Quadrangle had significant flexibility to achieve their architectural vision. The primary constraint was that the module sizing had to remain as originally constructed. Although the old frames remained in place, and the only component of the existing system removed was the vision glass, it is not possible for anyone on either the interior or exterior to tell that it is not a brand new system.

The new system has resulted in annual energy savings of over 35 per cent. Building operators report that they are much better equipped to regulate the interior temperatures throughout the building, significantly improving occupant comfort. Finally, the aesthetic upgrades have been successfully leveraged to attract and retain tenants. ■
